MISCELLANEOUS PAPER NO. 4-766

# TESTS WITH THE CH-47A CHINOOK HELICOPTER IN SOFT CLAY SOILS

January 1966

U. S. Army Engineer Waterways Experiment Station  
CORPS OF ENGINEERS  
Vicksburg, Mississippi

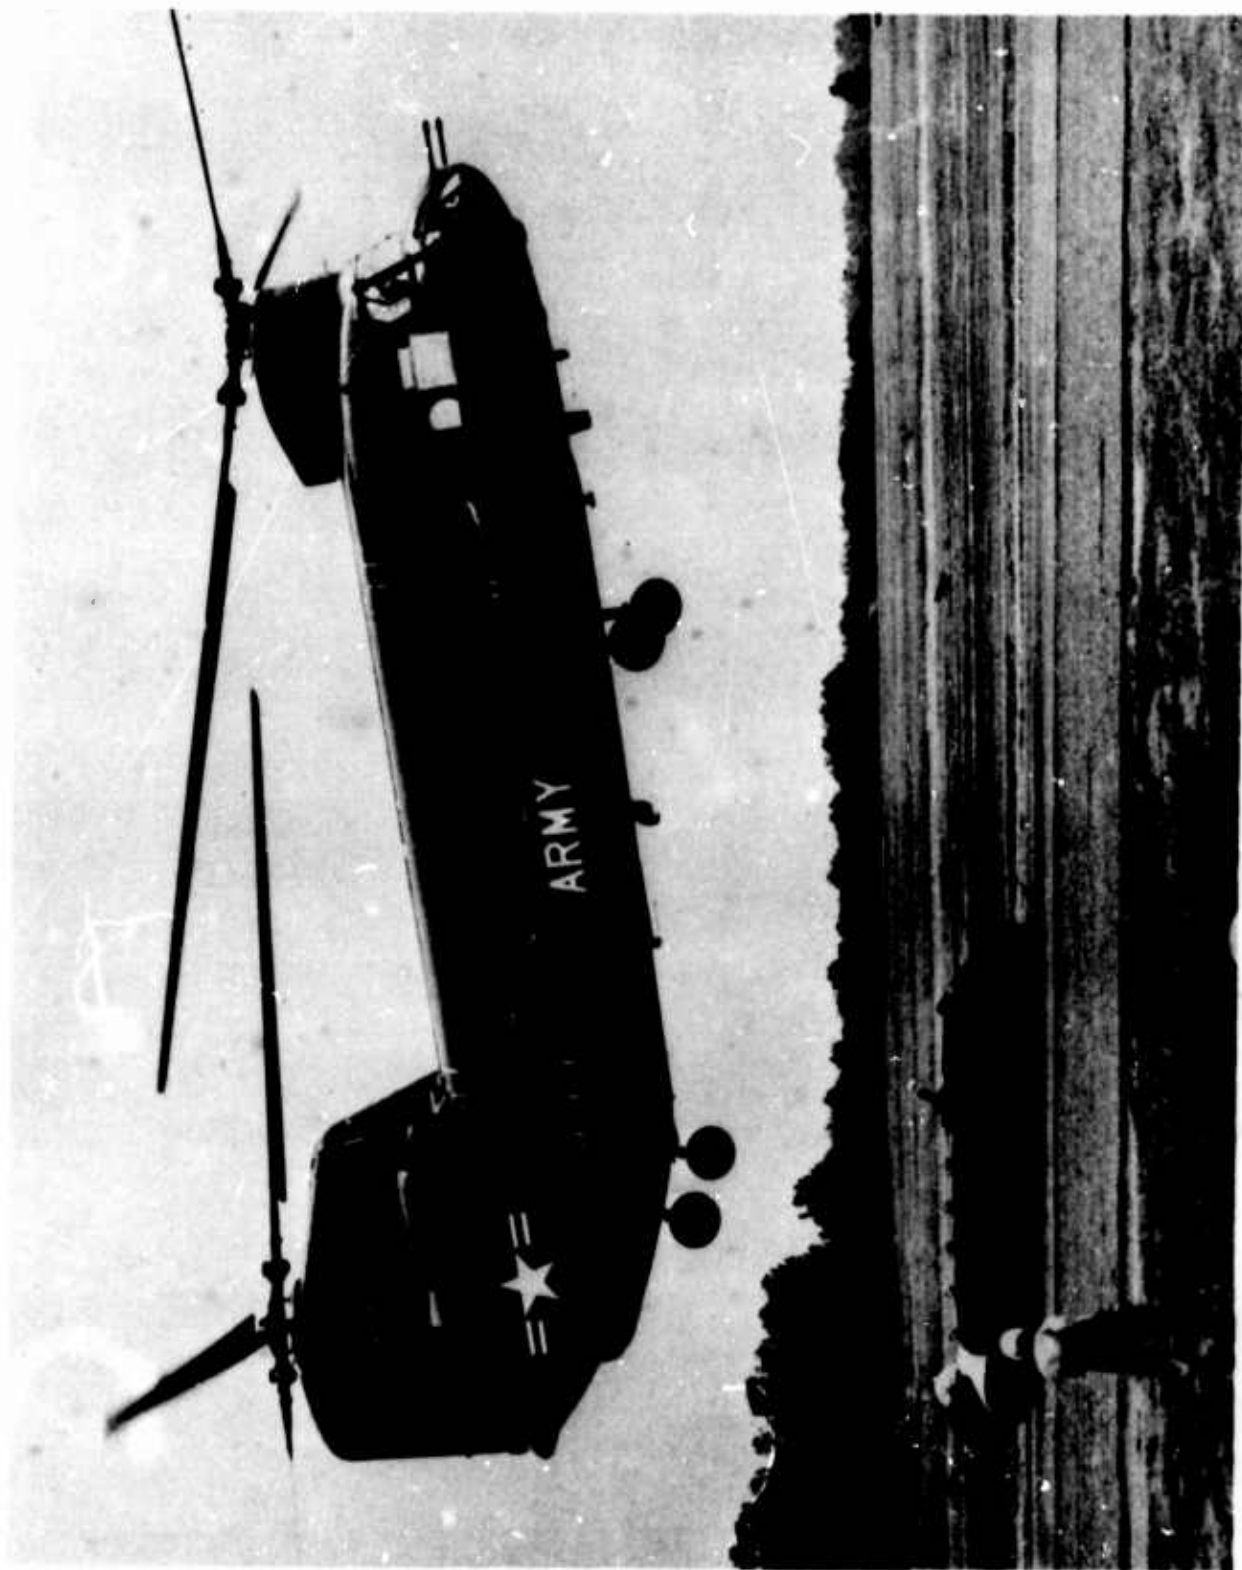
Photograph 1. CH-47A Chinook helicopter during lift-off

4. The CH-47A Chinook is shown in photograph 1. The following CH-47A data are those most pertinent to the program reported herein:

than all at once, as would be the case if the helicopter lifted evenly; this, therefore, eliminates to a great extent "suction" beneath the hull. Photograph 1 demonstrates the position of the helicopter on lift-off.

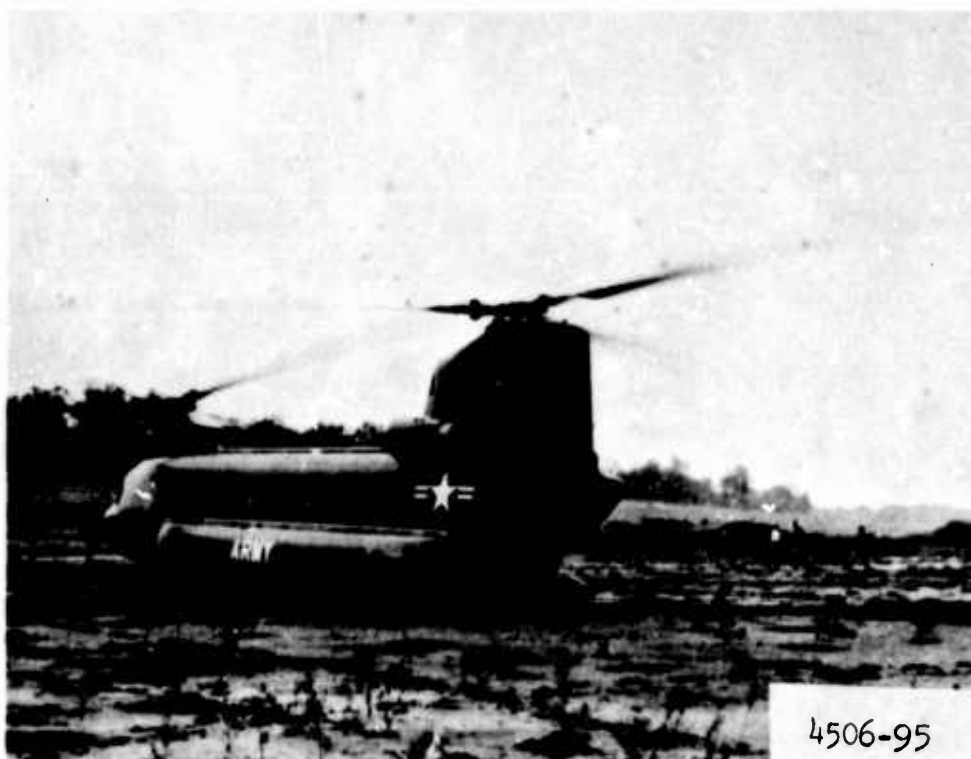
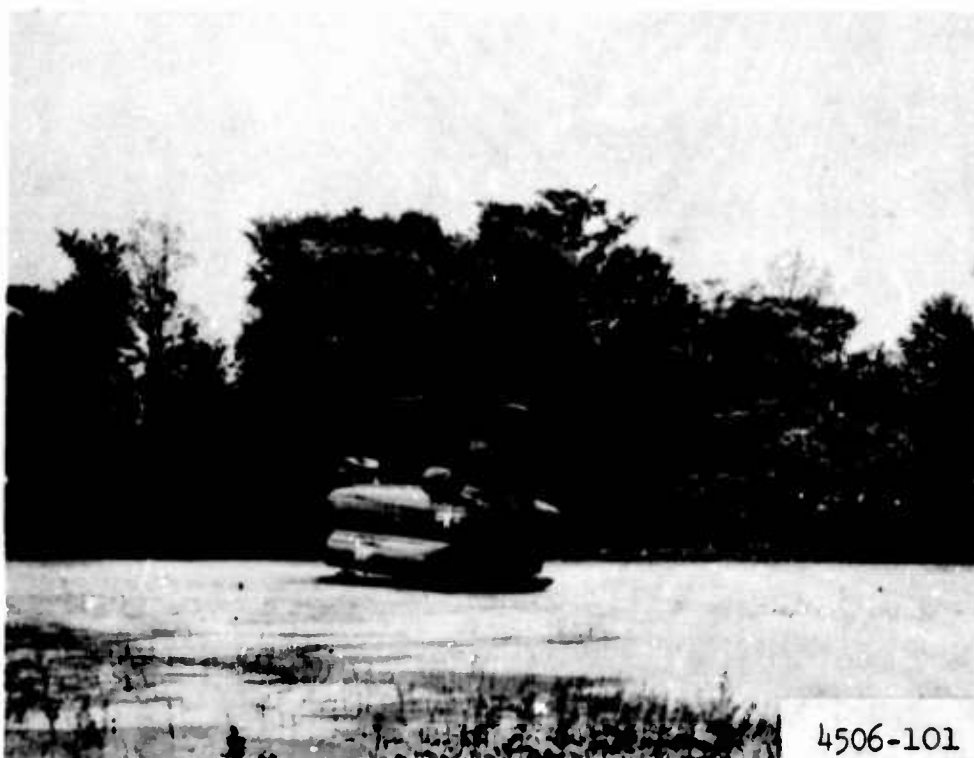
Photograph 2. Typical scenes of landings in borrow area

a. Test 8, no surface water, 12,330-lb payload

b. Test 9, 3 to 6 in. of water, 12,330-lb payload

6. This area was located south of a recently built backwater levee (see plate 1). The top few feet of soil had been removed during construction of the levee, leaving a vegetation-free, relatively flat surface. Tests were conducted at two sites within the area (see plate 2). One site, free of surface water but with a sticky soil surface, was the scene of two tests (tests 1 and 8); the other, where 3 to 6 in. of water was standing on the surface, was also used for two tests (tests 2 and 9). Typical scenes of tests in this area are shown in photograph 2.

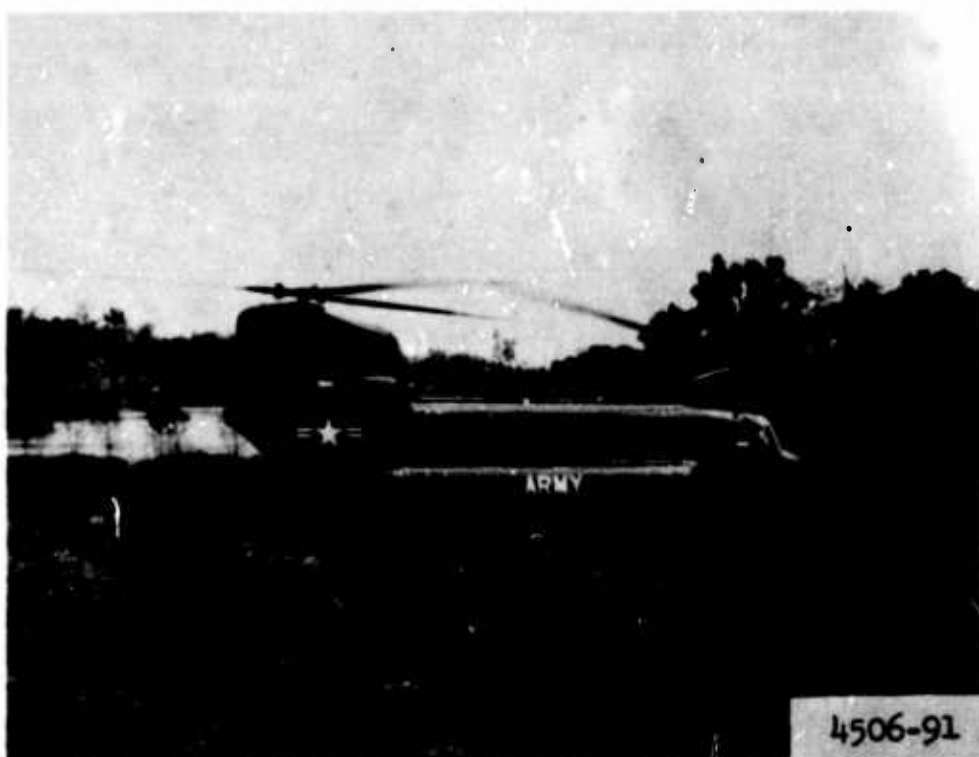
Photograph 3. Typical scenes of landings in lake area

a. Test 3, no payload

b. Test 10, 12,330-lb payload

7. This area was located north of the backwater levee at the southern end of Goose Lake (plate 1). A few small trees were removed from the area before testing. It is believed that the presence of root structure did not affect test results. The dry soil surface was free of vegetation and gave the impression of being firm although the subsoil actually was soft. Six tests (tests 3, 4, 6, 10, 11, and 12) were made in this area (see plate 3). Typical scenes of tests in the lake area are shown in photograph 3.

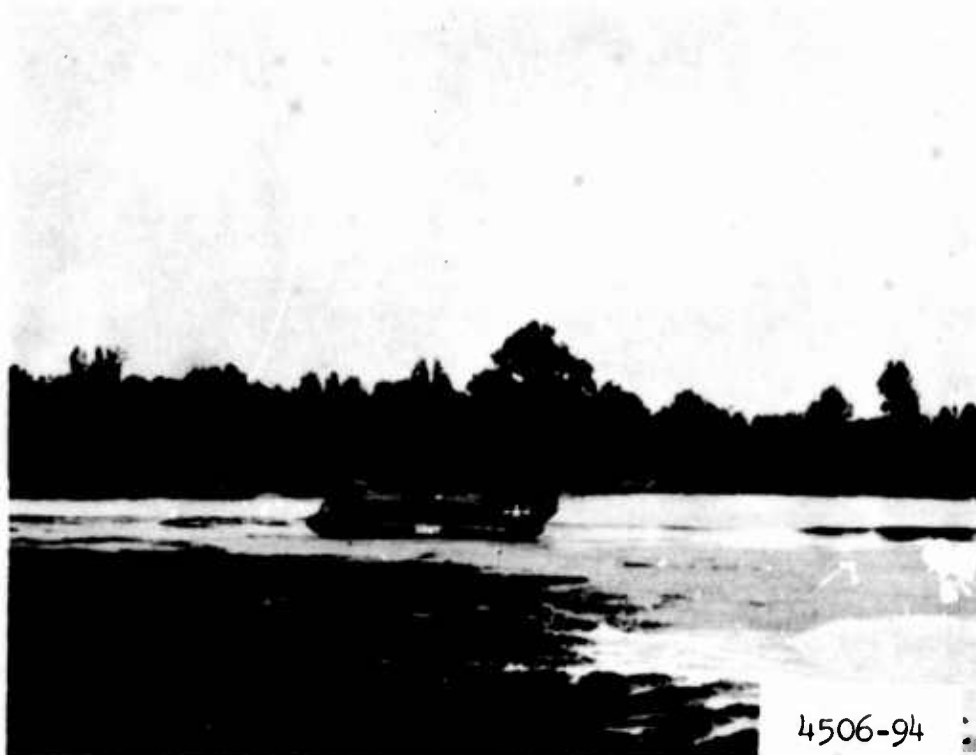
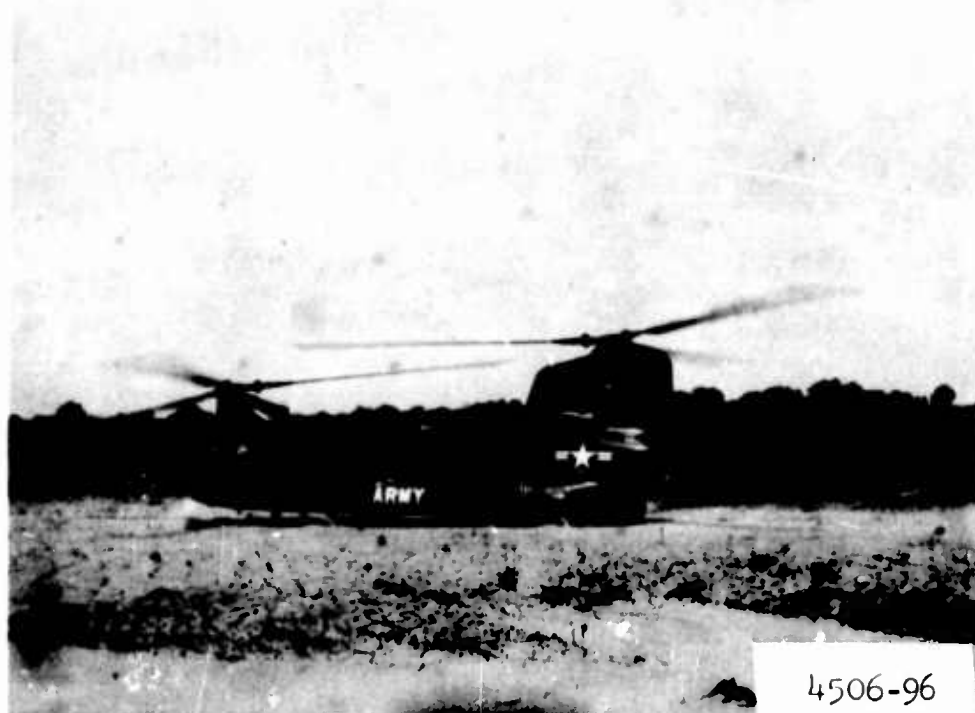
Photograph 4. Typical scenes of landings in spoil area

a. Test 13, no payload

b. Test 15, 12,330-lb payload

8. This area was located about 3-1/2 miles northeast of the other two areas. The site for three of the tests in this area (tests 5, 7, and 13) was inside a spoil retainer levee where dredgings from the Sunflower Diversion Canal had been pumped (see plate 4). The soil at this site was extremely soft to a depth of 6 ft. Two tests (tests 14 and 15) were made just outside the retainer levee where overflow from the spoil pit has been allowed to stand. At this site the soil was soft to a depth of about 15 in. and firm below that depth. Typical scenes of tests in this area are shown in photograph 4.

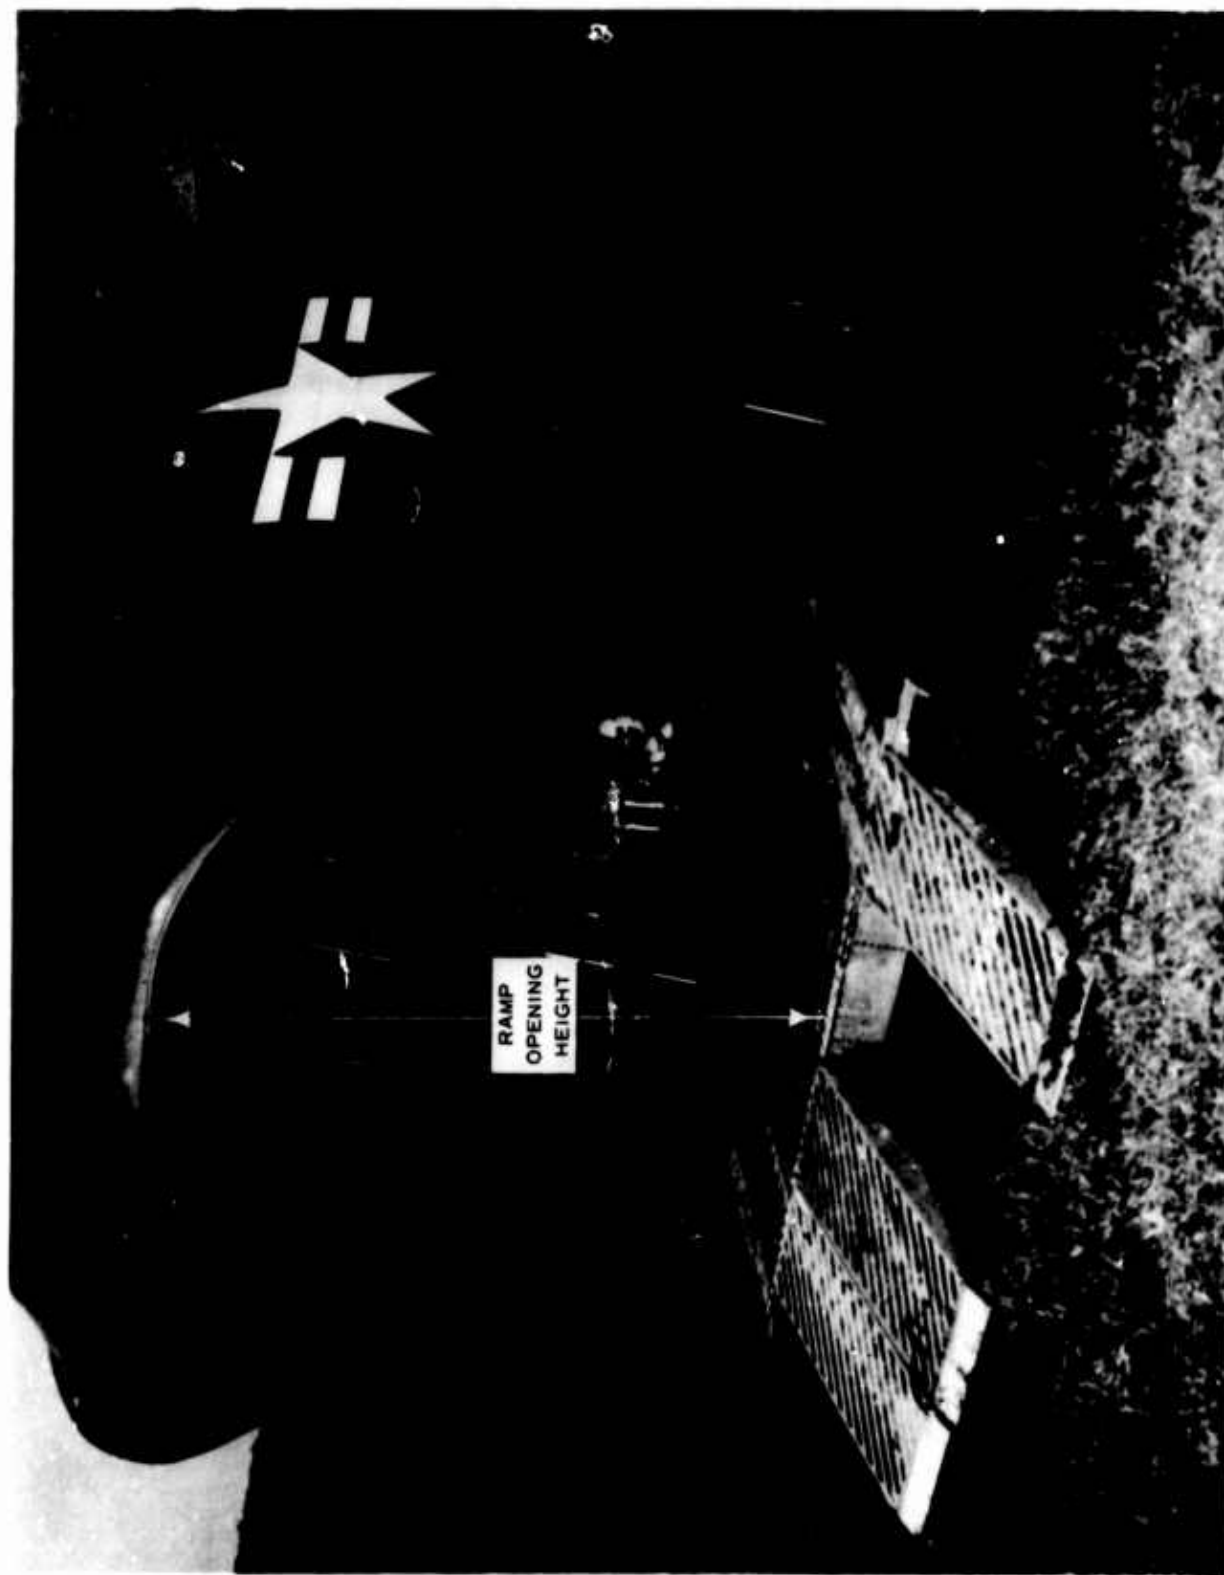
Photograph 5. Illustration of ramp opening height  
with Chinook resting on firm soil

15. Maximum ramp opening height. At the end of the rest period after each landing, measurements were made from the top of the cargo area opening, vertically to the aft edge of the ramp, to determine the maximum opening height. In photograph 5 it can be seen that the underside of the ramp is lower than the bottom of the hull and that the aft edge of the ramp actually rests on the soil surface. The ramp opening height was measured vertically from the inside aft edge of the ramp to a hull support member inside the helicopter above the ramp. This support member is in approximately the same plane as the top of the cargo space. The location

at which the ramp opening height was measured is shown in photograph 5.

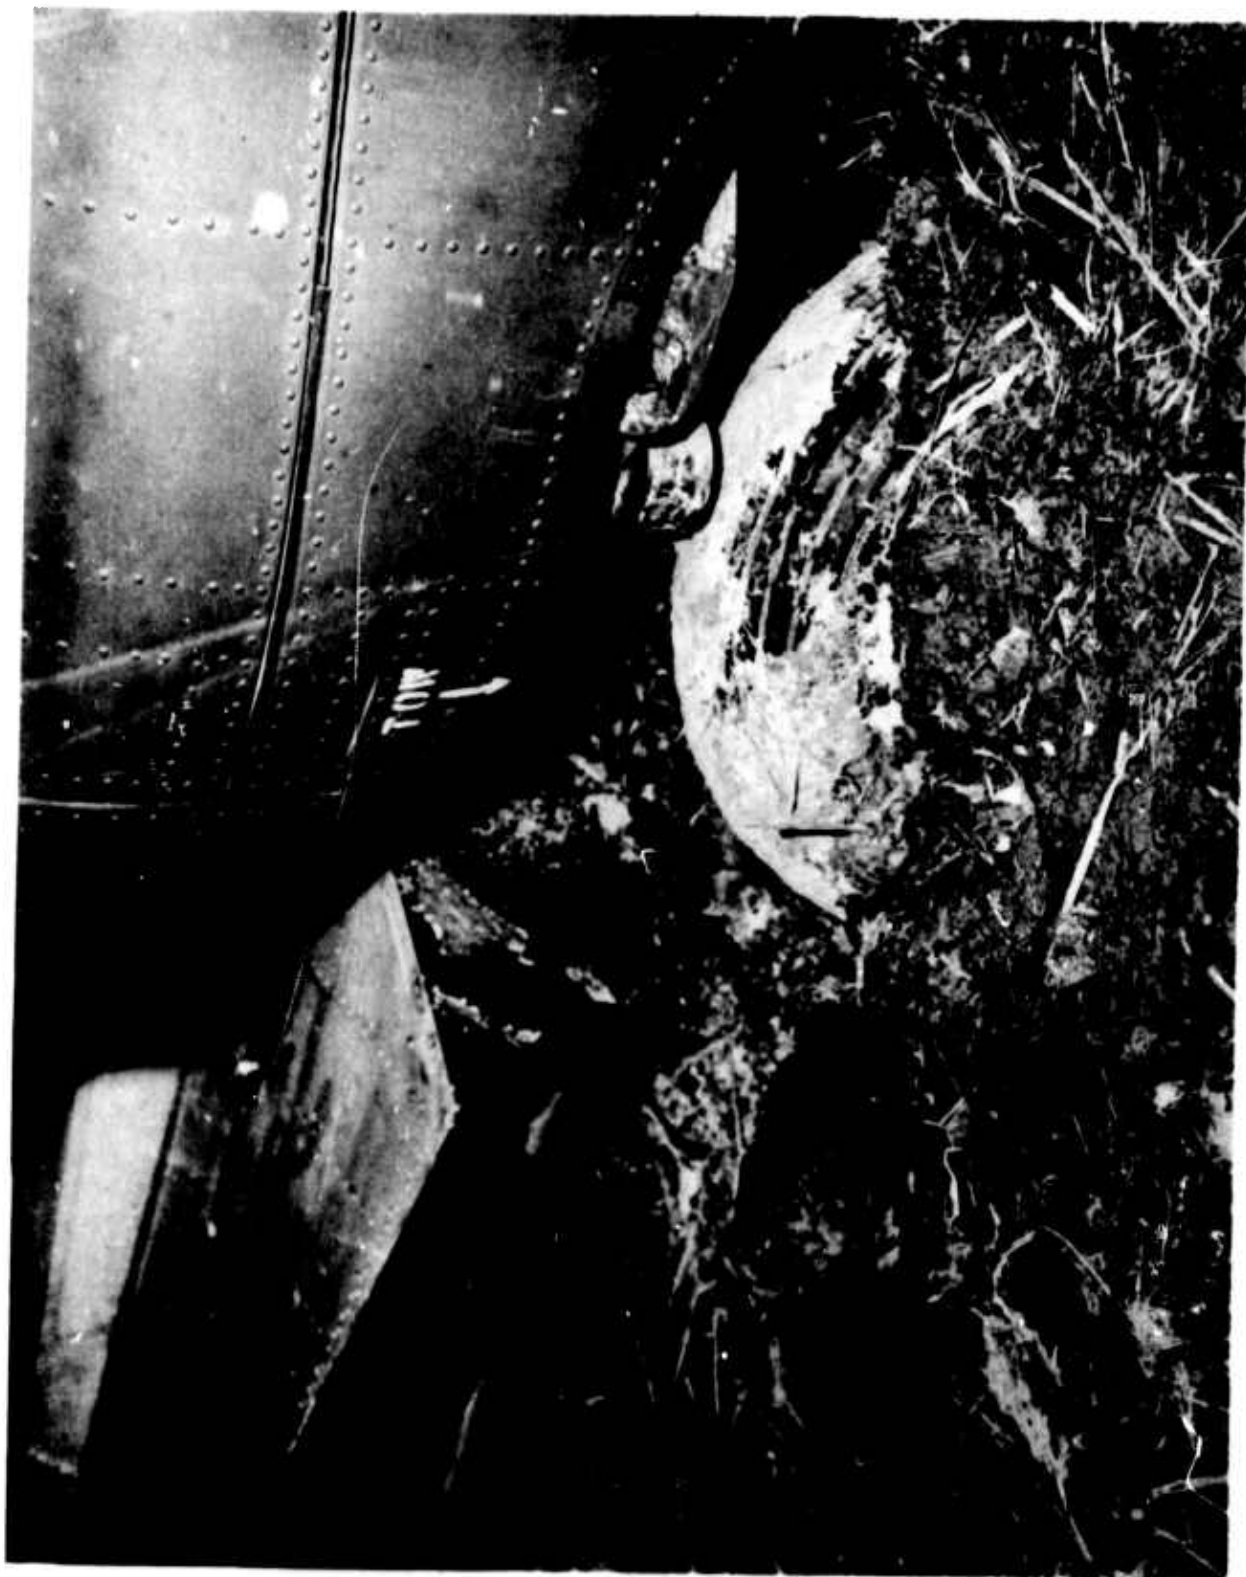
Photograph 7. Hinged end of ramp resting on soil when sinkage is deep

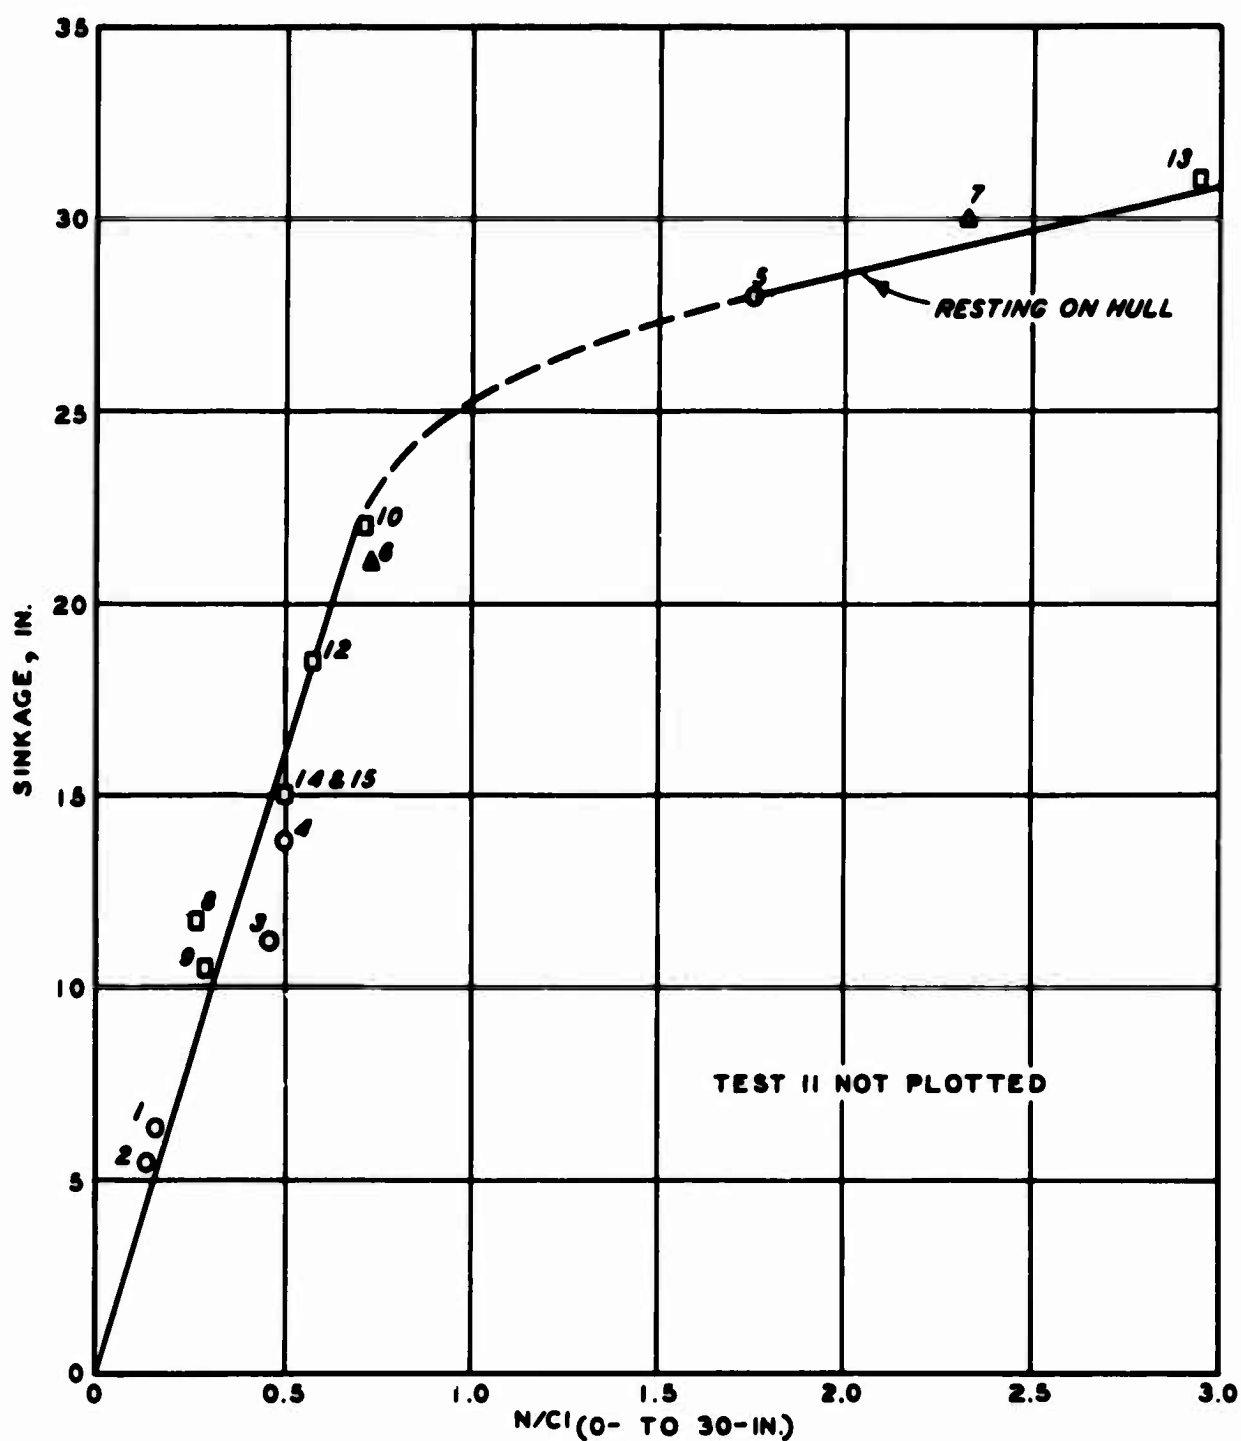
**SINKAGE VS  
BEARING PRESSURE-  
CONE INDEX RATIO**

NOTE:  $N = \frac{W}{b d n} = \frac{\text{VEHICLE WEIGHT}}{\text{NOMINAL TIRE WIDTH X TIRE DIAMETER X NUMBER OF TIRES}}$

24. To account for the effects of changes in both load and CI on sinkage, N was divided by the average CI in the 0- to 30-in. layer, and the resulting value was plotted against sinkage as shown in plate 5. It can be seen that a straight-line relation exists up to about 22-in. sinkage. At this sinkage a significant portion of the load probably is transmitted to the soil by the hull. Thus, after the helicopter sinks deep enough the hull contacts the soil, and further sinkage is restrained by the large supporting surface.

In plate 5 the  $N/CI$  ratio at a sinkage of 13.5 in., the depth at which the full tire diameter can be assumed to be in contact with the surface, is approximately 0.43. Thus, again the agreement is quite good.

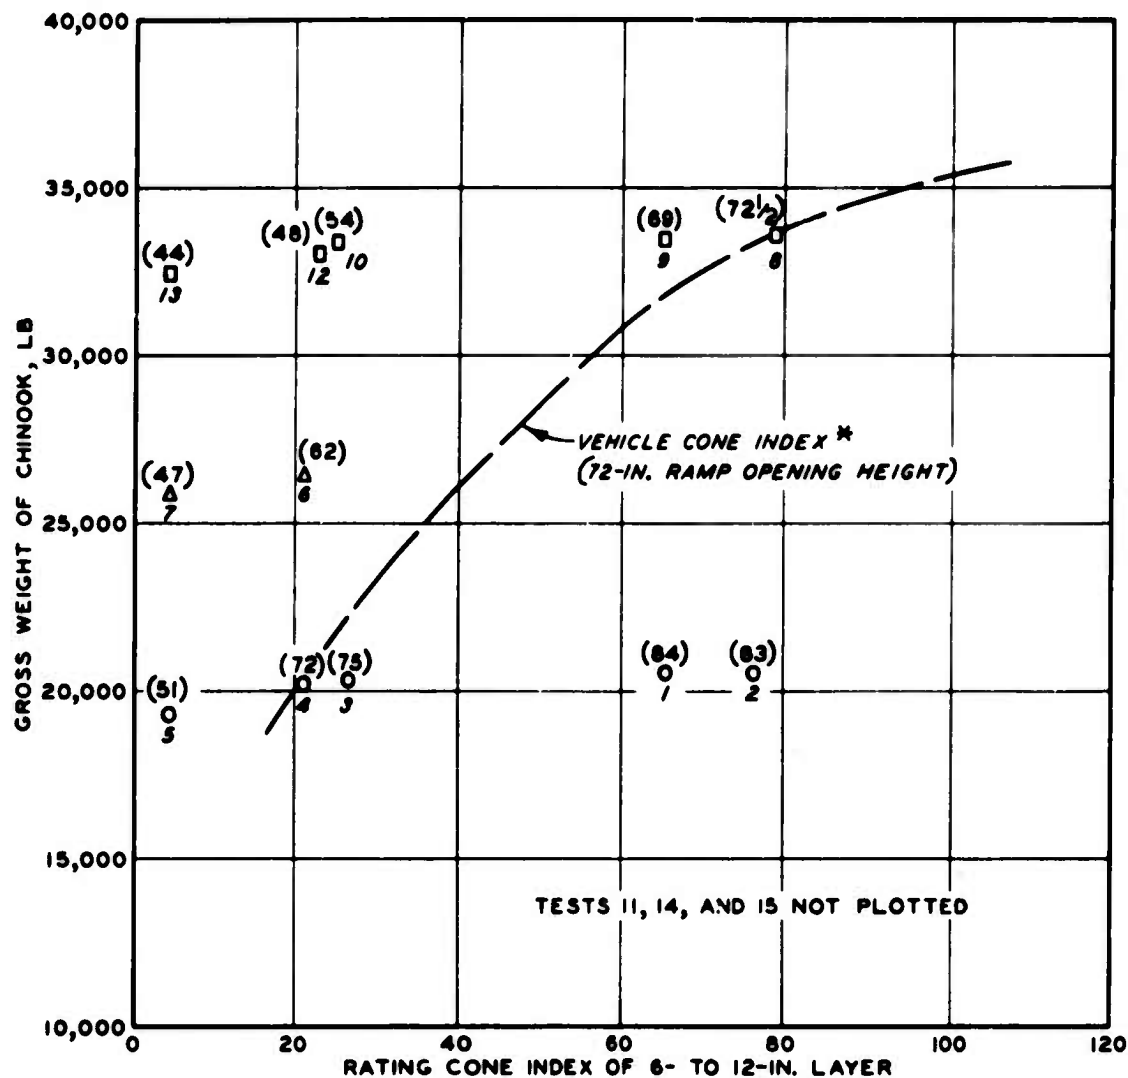
EFFECTS OF VEHICLE WEIGHT  
AND RATING CONE INDEX ON  
HEIGHT OF RAMP OPENING

NOTE: NUMBERS IN PARENTHESES OVER PLOTTED POINTS INDICATE RAMP OPENING HEIGHT IN INCHES. OTHER NUMBERS ARE TEST NUMBERS.

31. A plot was made (plate 7) of the test weight of the vehicle versus RCI of the 6- to 12-in. layer, and ramp opening heights were marked by each point. A curve was then drawn which separated ramp opening heights equal to or less than 72 in. from those greater than 72 in. This curve defines the Chinook VCI in terms of gross weight and soil condition for a 72-in. ramp opening height. Obviously, VCI's for the Chinook corresponding to other ramp opening heights could be determined in a similar manner.

32. The following example illustrates the above discussion. If it is assumed that the Chinook's gross weight is 30,000 lb when carrying a load that includes a vehicle that requires a minimum ramp opening height of 72 in., it must be concluded that the Chinook should not land in a soil condition in which RCI of the 6- to 12-in. layer is less than 56 (see plate 7). Despite the fact that such a soil would afford easy landing and takeoff of the Chinook and be more than adequate for the traffic of the ground vehicle(s) expected to be transported in the Chinook, the height of the maximum possible ramp opening would prohibit the discharge of the vehicle(s) on soil with a RCI of less than 56.
